TECHNICAL BULLETIN

MODEL/DERIVATIVE:
Discovery Series II (LT)

Bulletin N°: 0035
CDS. ref: L8927bu
Issue: 1
Date: 17.06.04

ENGINE OIL LEAK

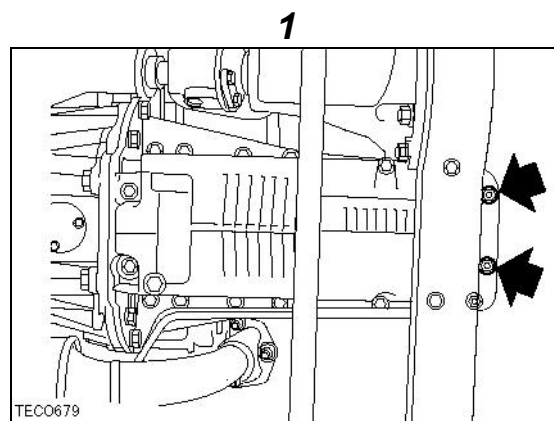
Oil leaks from the two sump front fixings.

It has been established that an oil leak path can develop down the threads of the sump front fixings.

1. Raise the vehicle on lift.
2. Remove two sump front fixing nuts (arrowed in illustration 1).
3. Remove two sump front fixing studs.
4. Clean studs and remove any excess oil from tapped holes.
5. Apply stud/bearing fit (STC50552) to the stud threads that engage in front cover.
6. Install the studs into the oil pump/timing gear cover until they protrude 27 mm from the oil pump/timing gear cover joint face (or 12.5mm from the sump face).
7. Wipe off any excess sealant.
8. Fit sump retaining nuts and tighten to 22Nm (16lbf.ft).
9. Lower vehicle.
