# TECHNICAL BULLETIN

*MODEL/DERIVATIVE:*  
New Discovery  
Defender

*Bulletin N°:* 0010  
*CDS. ref:* L8471bu  
*Issue:* 1  
*Date:* 28.10.98

## FUEL COOLER FIXINGS - CHANGE TO TORQUE SPECIFIED

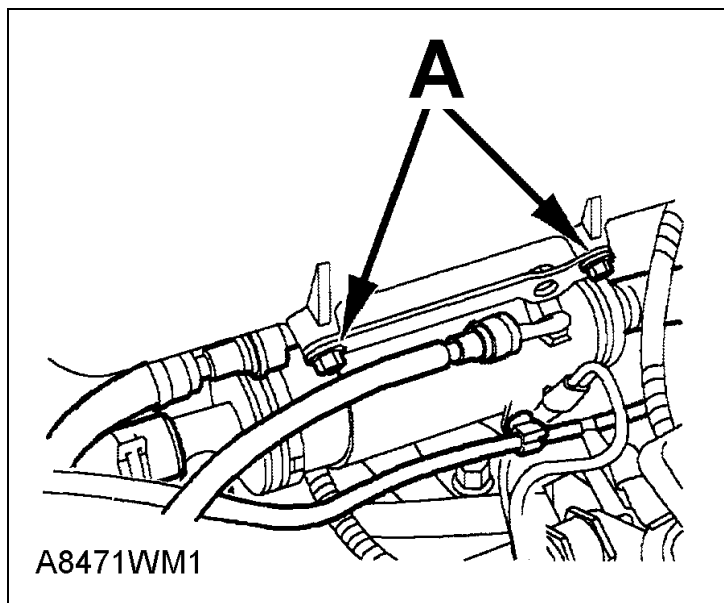
There is a risk of stripping the inlet manifold threads for the upper two fuel cooler mounting screws when tightening to the originally specified torque.

Insufficient screw thread engagement in the inlet manifold to support the tightening torque normally specified for an 8mm screw fixing.

1. Clean the two upper fixing screws, (A in illustration) and the inlet manifold threads, apply Loctite 242 to the screw threads and refit the screws to the inlet manifold.
2. Tighten the screws A to the revised torque of 18Nm.
3. The lower fixing screws torque remains at 25Nm and Loctite is not required.

- Discard the two upper fixing screws, clean the inlet manifold threads and fit new patchlock screws FS108127ML.
- Continue as 2 and 3 above.
