VCM Failure

Issue:

An issue has been identified that can cause a partial or complete failure of the VCM.

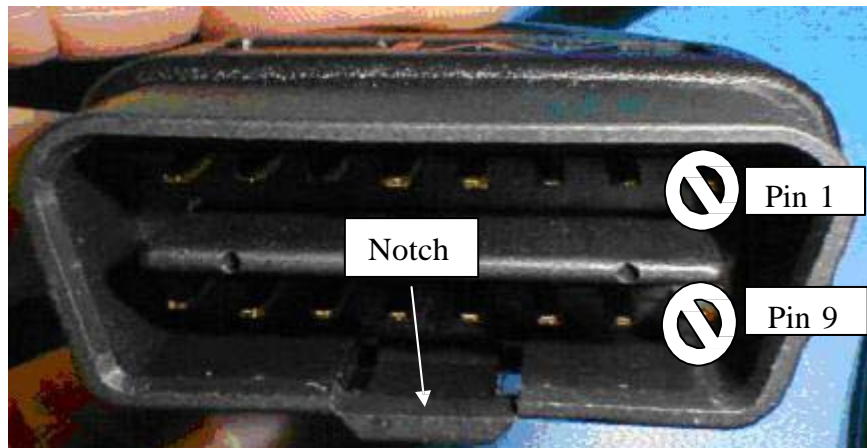
1. Before proceeding Index the DLC in the following manner. Make note of the Pins which require removal.

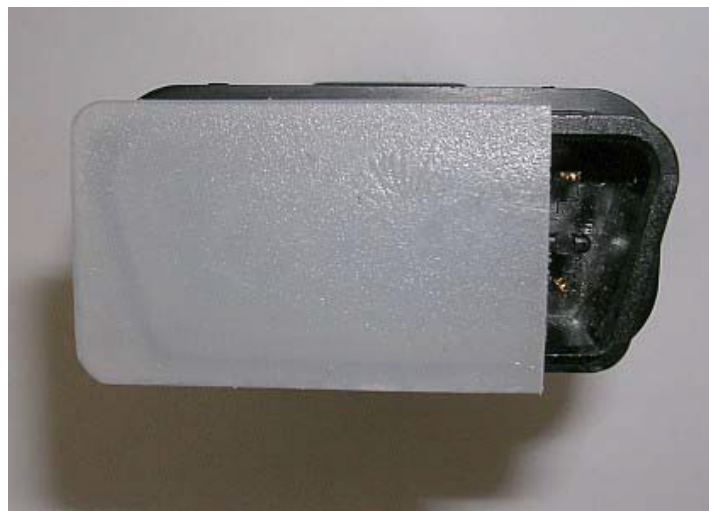
The picture above shows which pins will have been removed if the instructions have been followed correctly.

2. Locate the Guide Template and fit it onto the end of the DLC cable so that it only exposes the pin to be removed

3. Locate the Pin Removal Tool overtop of the pin 1 and twist clockwise to remove each pin, repeat for pin 9.
