Technical Tip

Nº:	TT0044 Issue 1
Date:	13.05.2002
Section:	ELECTRICAL

Rover 618, 620, 623 petrol (PGM-FI)

DIAGNOSTIC CONNECTOR NOT AVAILABLE

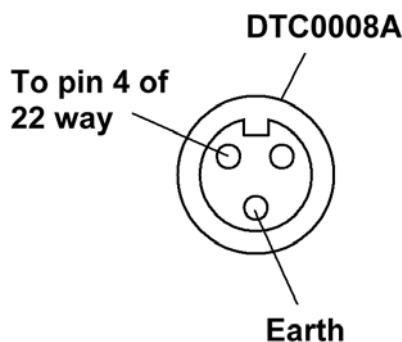
New keys and re-programming cannot be carried out as there is no diagnostic connector fitted to these vehicles.

1. Switch the ignition off and remove the key from the ignition switch.
2. Fold back the carpet in the passenger footwell to reveal the PGM-Fi E.C.U.
3. Undo the 4 x 10 mm nuts holding the PGM-Fi E.C.U. in place so access can be gained to the wires and the connectors of the PGM-Fi.

4. Locate the lower of the 3 connectors. i.e. 22 way connector.
5. From the 22 way connector, locate the light green wire with the red tracer leading to pin 4.
6. Position T4 / TestBook lead DTC0008A close to the 22 way connector.
7. Using suitable connecting probes, connect the light green wire / red tracer from the 22 way connector to the light green / red tracer wire of diagnostic lead DTC0008A.
8. Connect a suitable temporary earth wire between the black wire terminal pin of diagnostic lead DTC0008A and a suitable earth on the vehicle, i.e. the earth point at the bottom of the 'A' post.
9. Switch ignition on and carry out re-programming by selecting 'Diagnostics' from the welcome screen, then select Rover 600 and RED KEY PGM-Fi. Follow instructions on screen.
10. When done, disconnect probes and refit the PGM-Fi E.C.U.
