TECHNICAL BULLETIN

MODEL/DERIVATIVE:
Discovery Series II (LT)

Bulletin N°: 0015
CDS. ref: L8895bu
Issue: 2
Date: 27.01.04

RADIATOR TOP COOLANT HOSE - LEAKING
ACE high-pressure hose chafing radiator top coolant hose.

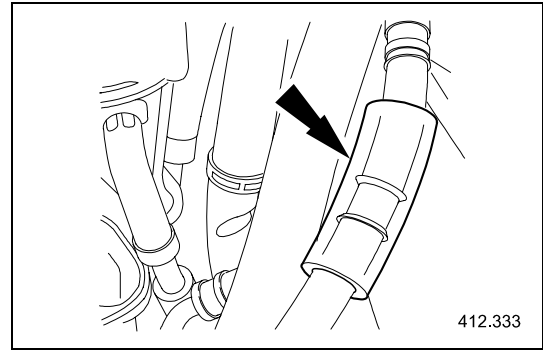
1

The route taken by either hose is variable, resulting in a possible foul condition. The foam protector that covers the ACE hose crimp can wear through, allowing the crimp to contact the top coolant hose. This can result in abrasion damage to the coolant hose.

5. If installed, remove the foam protector from the ACE high pressure hose, and discard (see illustration 1).
