# TECHNICAL BULLETIN

LTB00487v6  
09 JUN 2015

### 3.0 TDV6 Excessive Exhaust Smoke

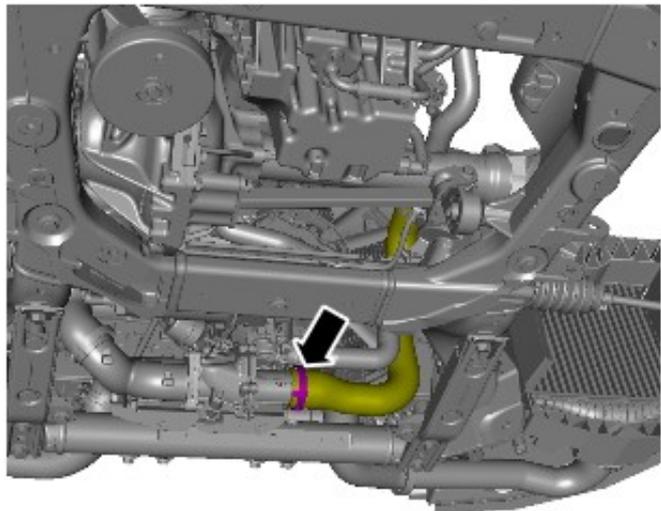
E153388

Disconnect the hose from the turbocharger bypass valve.

- Position a suitable container to catch any fluids.
- Release the clip.

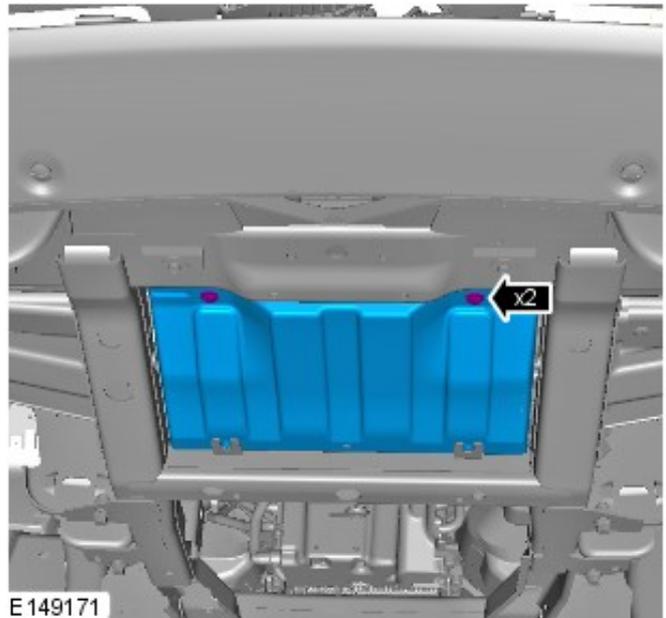
5. Remove the undershield.
- Remove the 2 bolts.

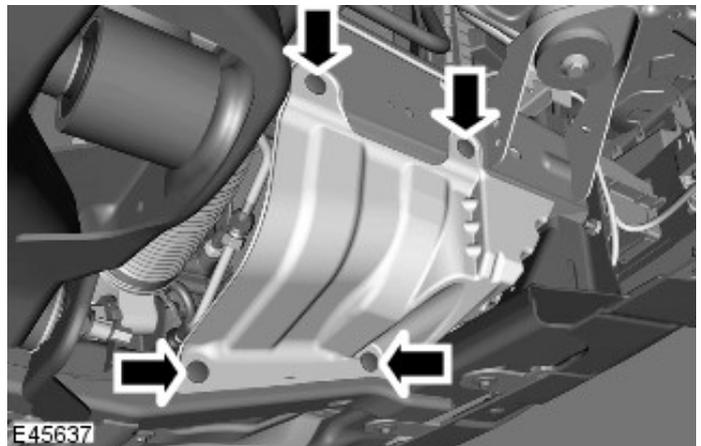
**6.** Remove the right radiator side shield.

- Remove the 4 clips.

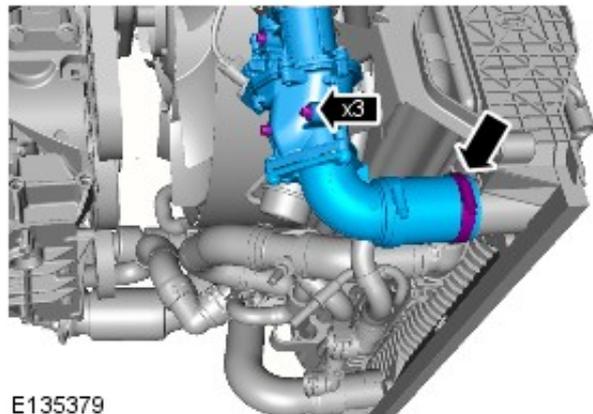
Release the turbocharger bypass valve.

- Position a suitable container to catch any fluids.
- Release the clip.
- Remove the 3 bolts.

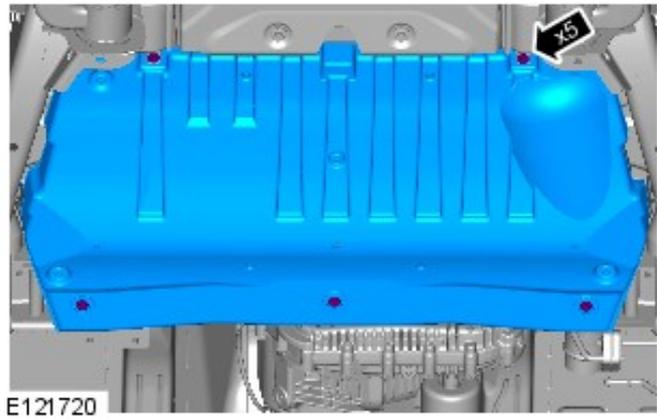
**9.** Remove the transmission undershield.

- Remove the 5 bolts.

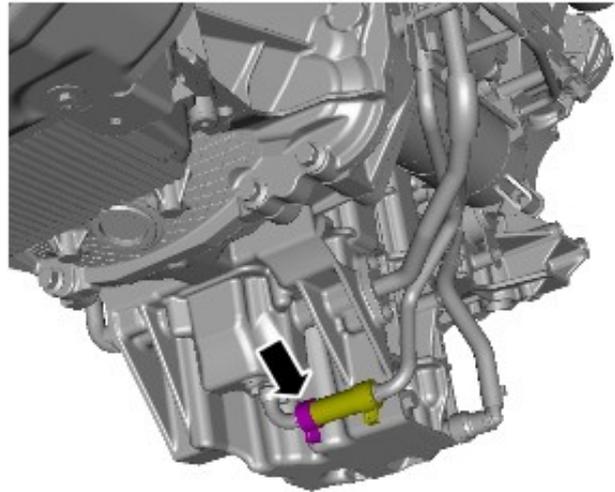
E149118

**10.** Drain the excess oil.

- Position a suitable container to catch any fluids.
- Release the clip.
- Disconnect the hose.
- Allow the oil to drain.
- Secure the clip and hose.

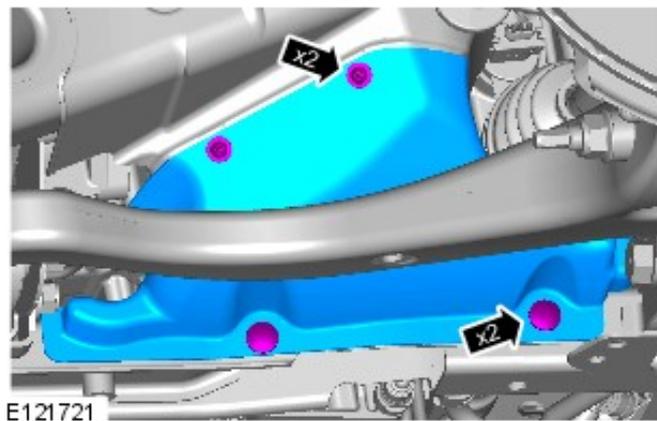
E121721

**11.** If equipped, remove the shield.

- Remove the 2 bolts.
- Remove the 2 clips.

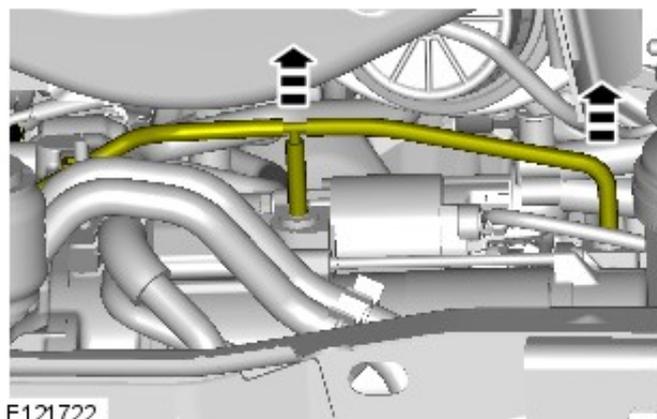
E121722

**12.** Release the starter motor snorkel tube.

- Disconnect the 2 hoses.

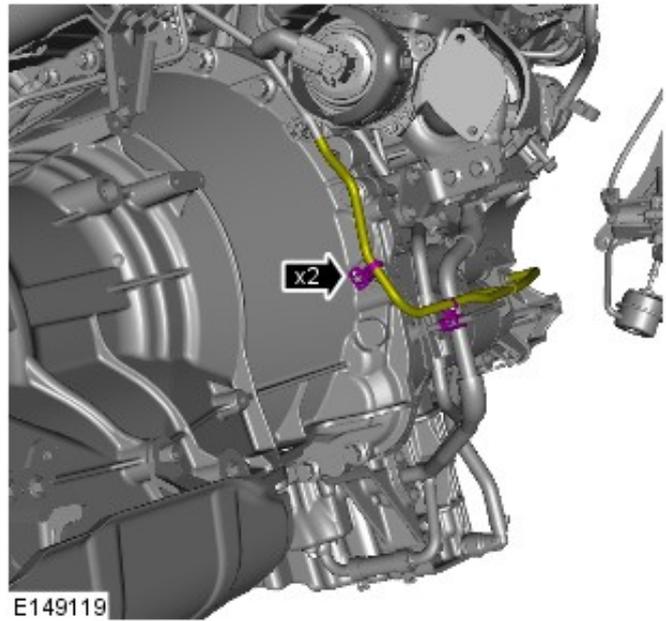
**13.** Release the starter motor snorkel tube.

- Release the 2 clips.

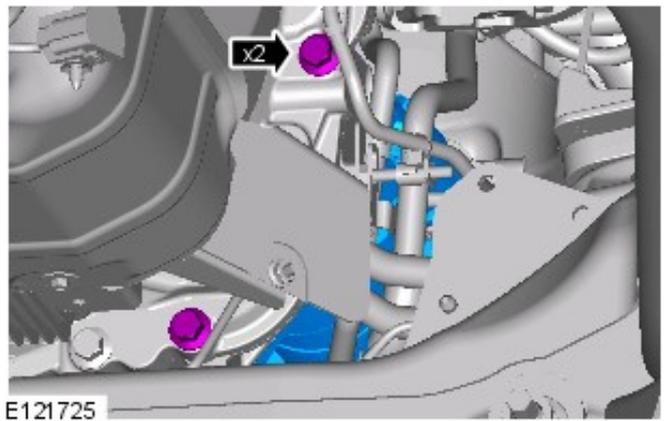
**14.** Release the starter motor.

- Remove the 2 bolts.

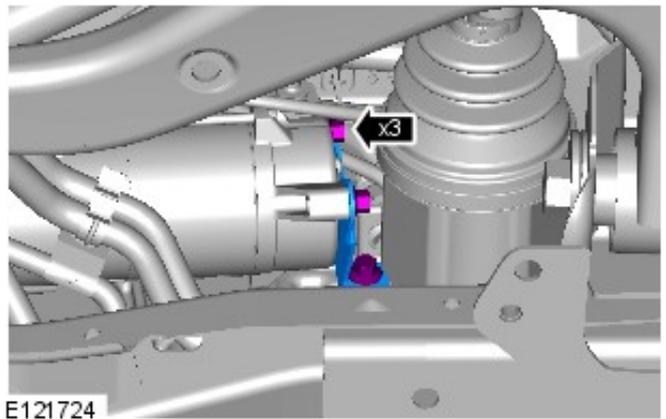
**15.** Remove the starter motor bracket.

- Remove the 3 bolts.

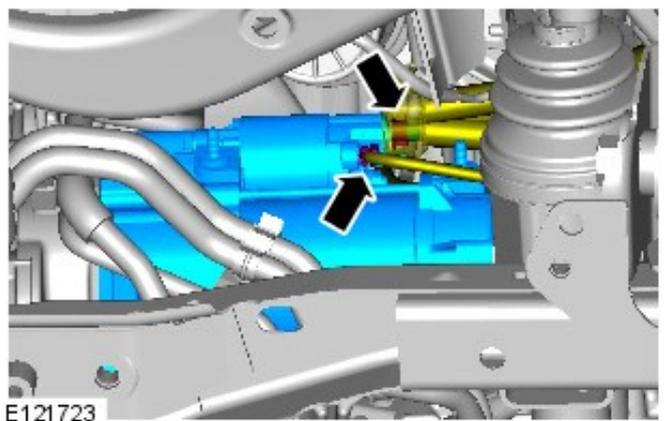
**16.** Disconnect the 2 electrical connectors.

- Reposition the insulation for access.

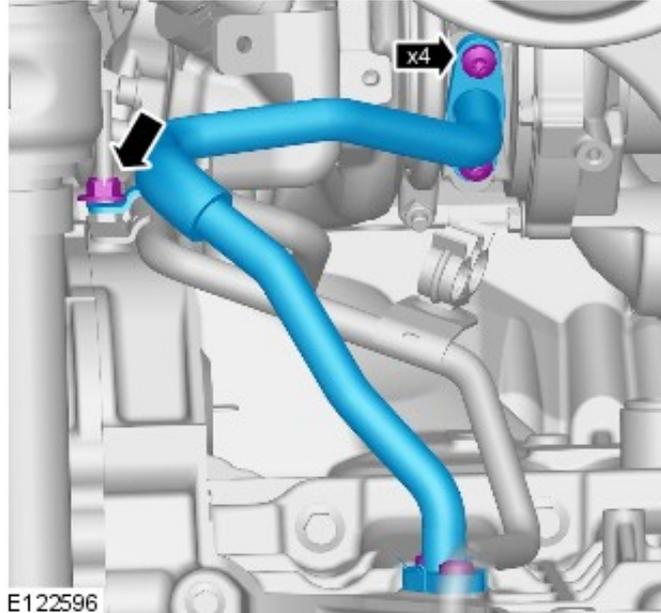
18. Remove and discard the oil drain tube.

- Position a suitable container to catch any fluids.
- Remove the 4 Torx bolts.
- Remove and discard the nut.
- Remove and discard the 2 gaskets.

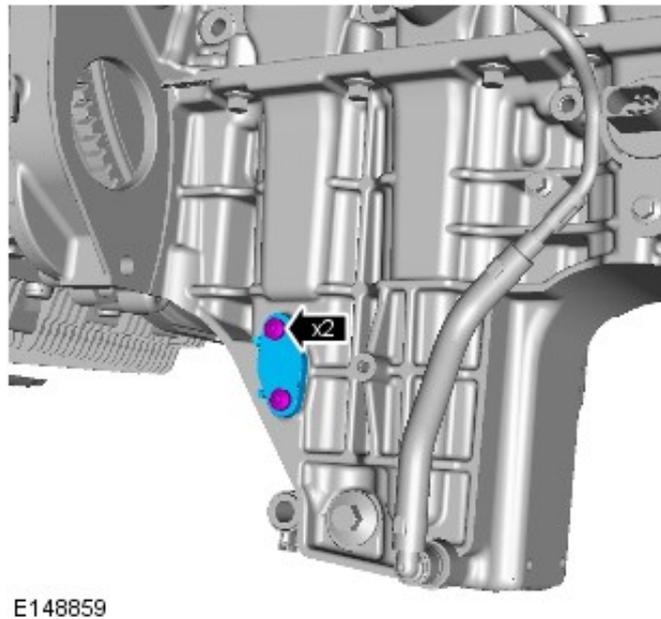
**CAUTION: Make sure that the gasket is correctly located on the blanking plug.**

Install the blanking plug.

- Torque: 10 Nm

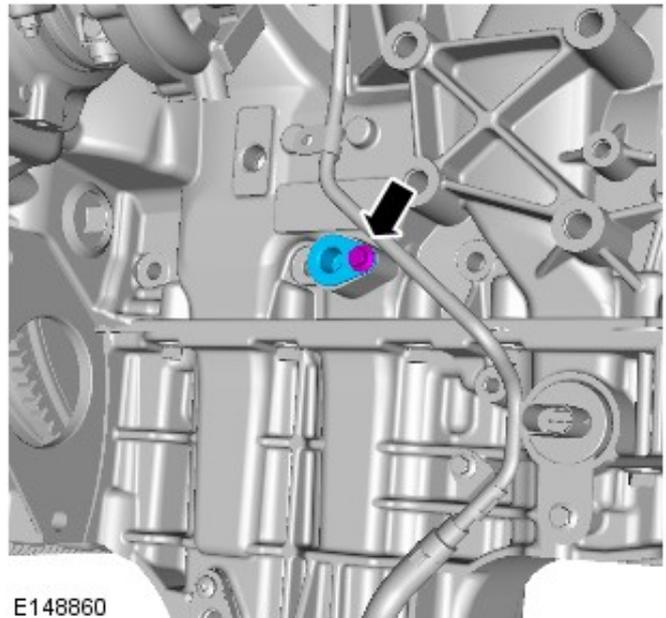
20. Remove and discard the blanking plug.

- Remove the bolt.

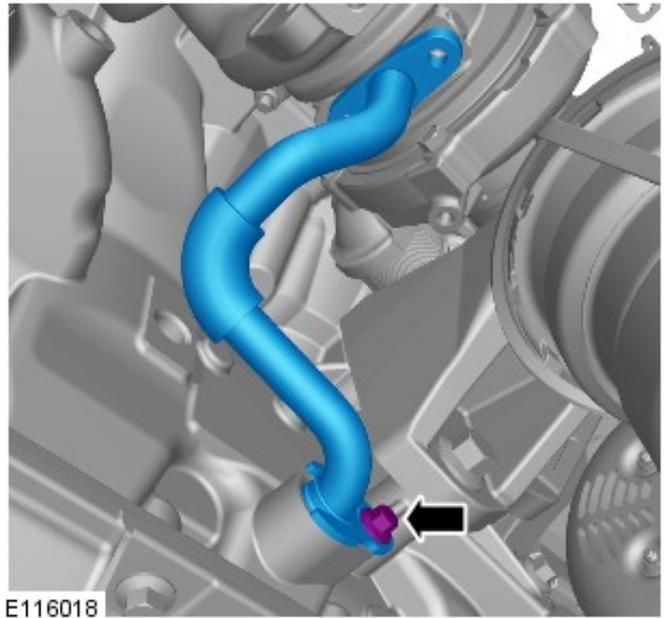
**CAUTION: Make sure that the o-ring seal is correctly located on the oil drain tube.**

Install the new oil drain tube.

- Torque: 10 Nm

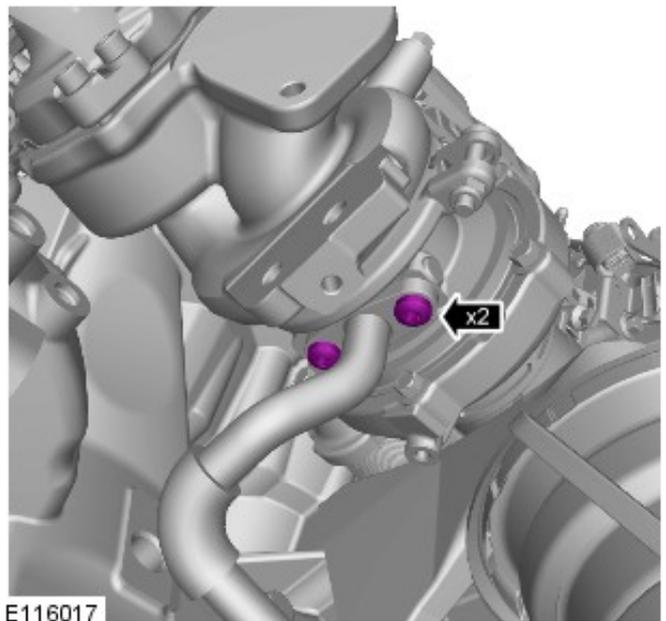
**CAUTION: Make sure that the gasket is correctly located.**

Secure the oil drain tube.

- Install the new gasket.
- Torque: 10 Nm

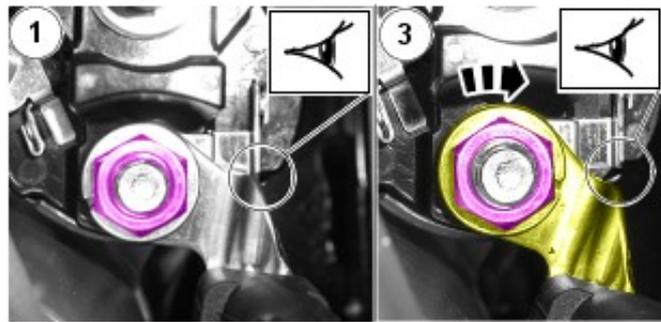
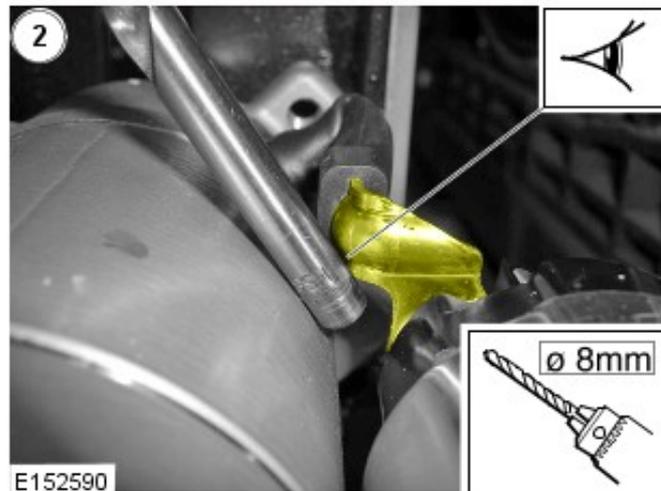
**CAUTION: Make sure that the starter**

**motor cable is positioned as shown, failure to follow this instruction may result in damage to the vehicle.**

**NOTE: Use a 8mm drill bit to gauge the gap between the cable and the starter motor body.**

Adjust the position of the starter motor cable.

1. Slacken the nut.
2. Adjust the cable to achieve a 8mm gap between the cable and the starter motor body.
3. Whilst maintaining the gap shown, tighten the nut to 7 Nm.

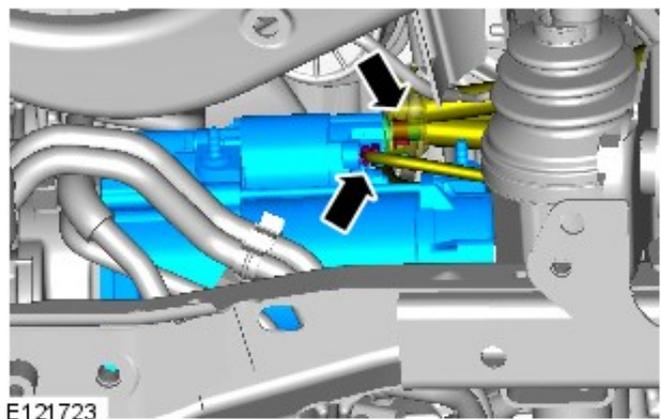
**24.** Connect the 2 electrical connectors.

- M8 Torque: 10 Nm
- M6 Torque: 7 Nm
- Reposition the insulation over the connectors.

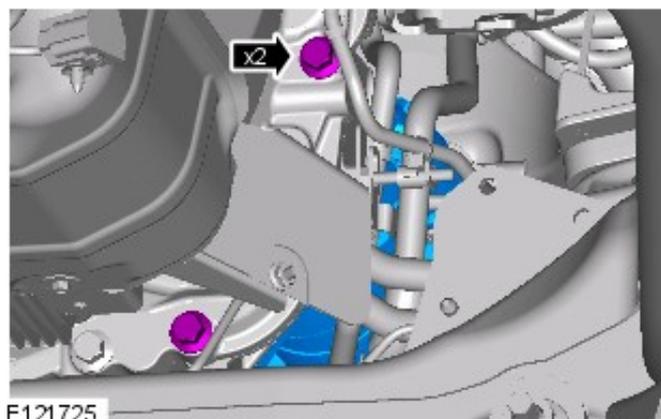
**25.** Secure the starter motor.

- Torque: 47 Nm

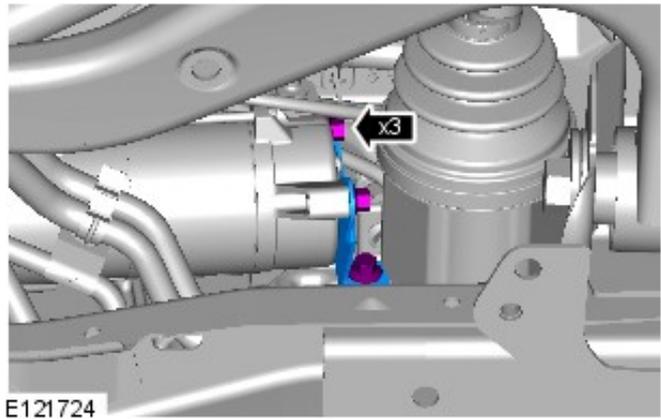
E121724

**26.** Install the starter motor bracket.

- Torque: 47 Nm

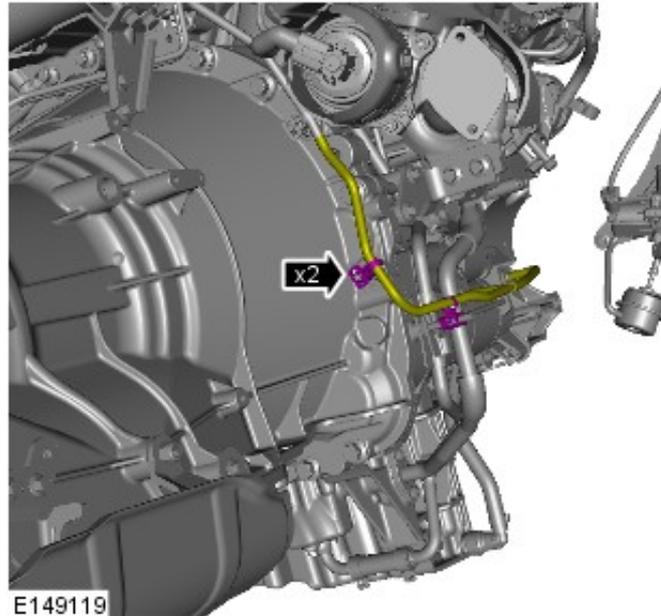
E149119

**27. Secure the starter motor snorkel tube.**

- Secure the 2 clips.

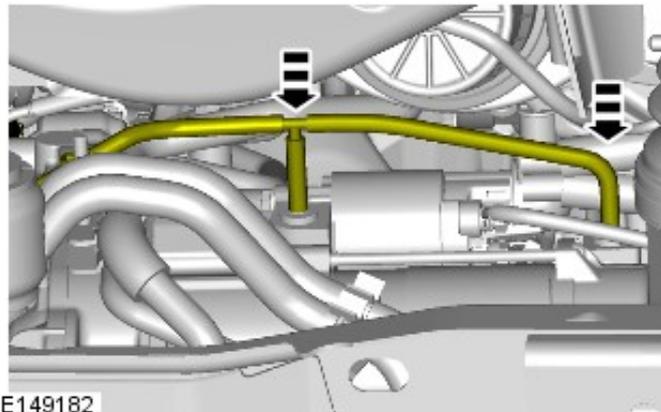
E149182

**28. Connect the starter motor snorkel tube.**

- Connect the 2 hoses.

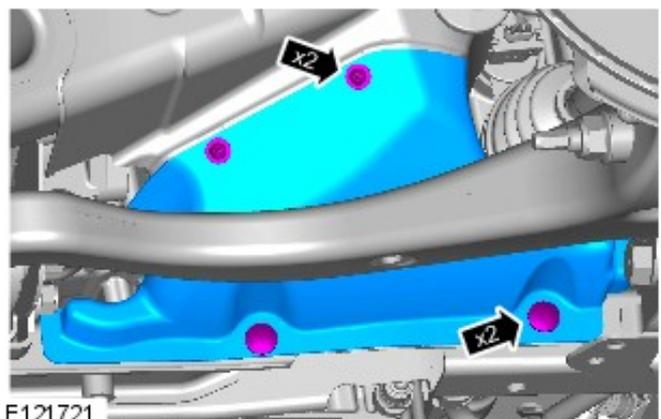
E121721

**29. If equipped, install the shield.**

- Tighten the 2 bolts.
- Secure the 2 clips.

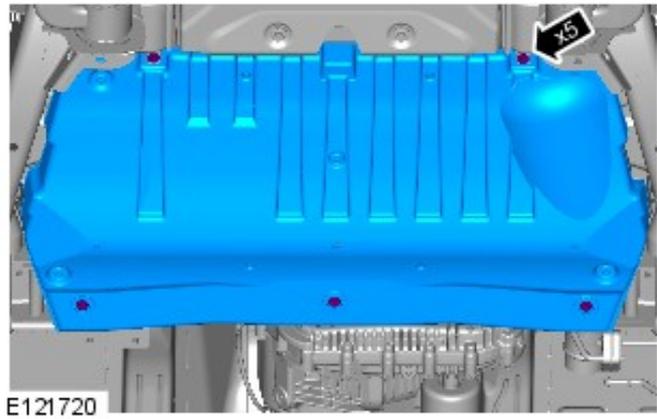
**30. Install the transmission undershield.**

- Torque: 10 Nm

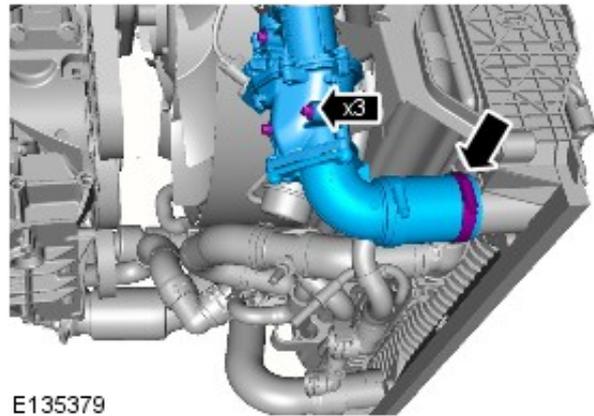
**31. Install the engine undershield (see TOPIx Workshop Manual, section 501-02).****32. Secure the turbocharger bypass valve hose.**

- Using a suitable cloth, wipe away any fluid from the hose.
- Clip Torque: 5 Nm
- Bolts Torque: 10 Nm

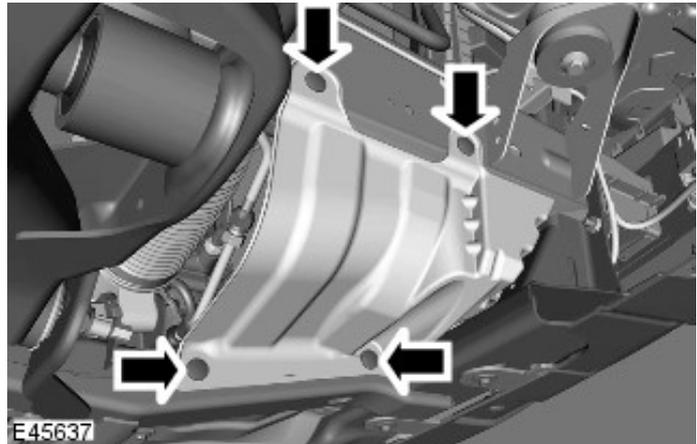
**33. Install the right radiator side shield.**

- Secure the 4 clips.

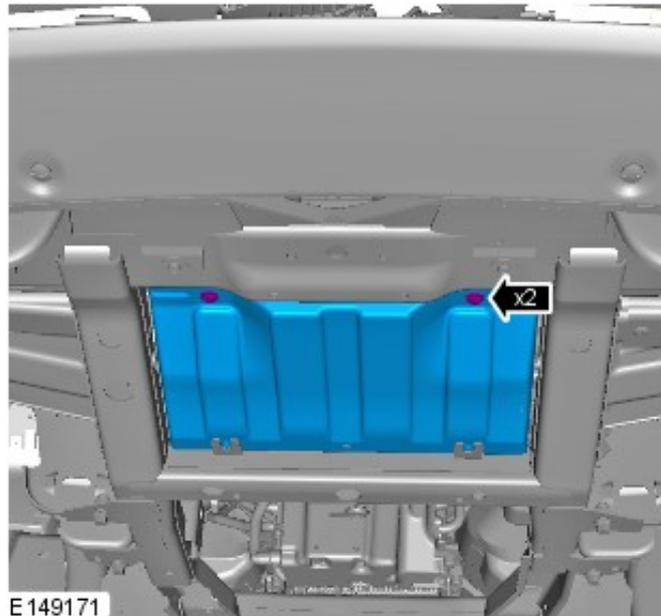
**34. Install the undershield.**

- Tighten the 2 bolts.

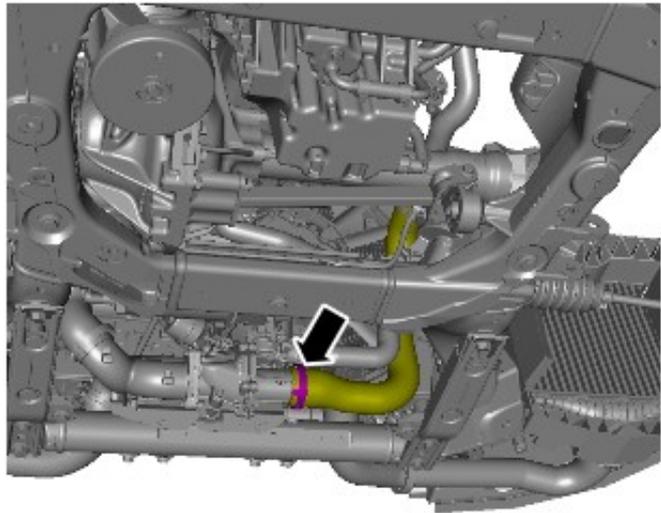
E153388

- 35.** Secure the turbocharger bypass valve hose.
- Using a suitable cloth, wipe away any fluid from the hose.
  - Torque: 4 Nm
